TECHNICAL REPORT ARLCD-TR-78C17

**FAILURE ANALYSIS OF THE LIGHTWEIGHT
COMPANY MORTAR SYSTEM 60 MM MORTAR FIN**

SEPTEMBER 1978

**US ARMY ARMAMENT RESEARCH AND DEVELOPMENT COMMAND
LARGE CALIBER
WEAPON SYSTEMS LABORATORY
DOVER, NEW JERSEY**

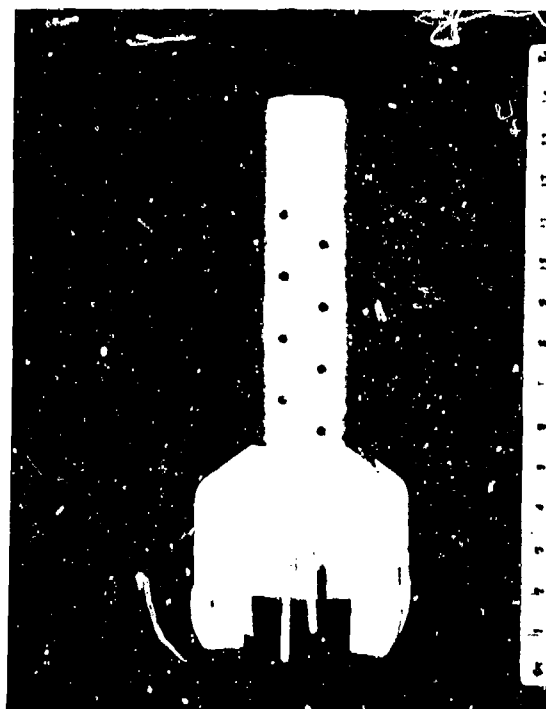
An investigation of the failure mechanism and mode was begun at Frankford Arsenal and Picatinny Arsenal, during which 1800 fins were subjected to mandrel tests resulting in another seven failures similar in nature to those experienced during test firing. A typical "normal" mandrel failure is shown in figure 2.

Figure 2. Typical normal fin failure.

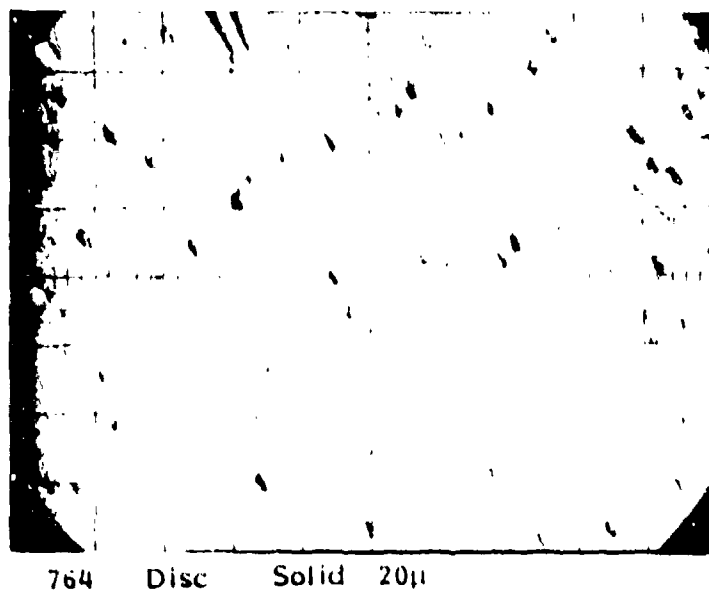
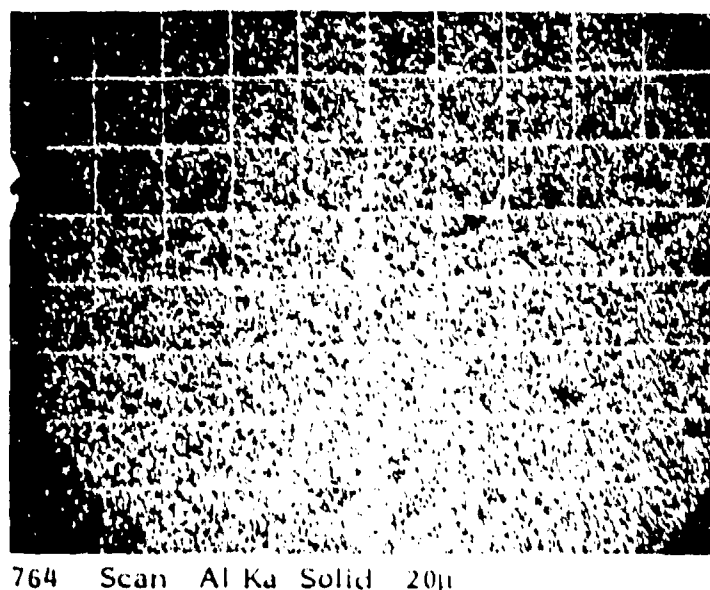
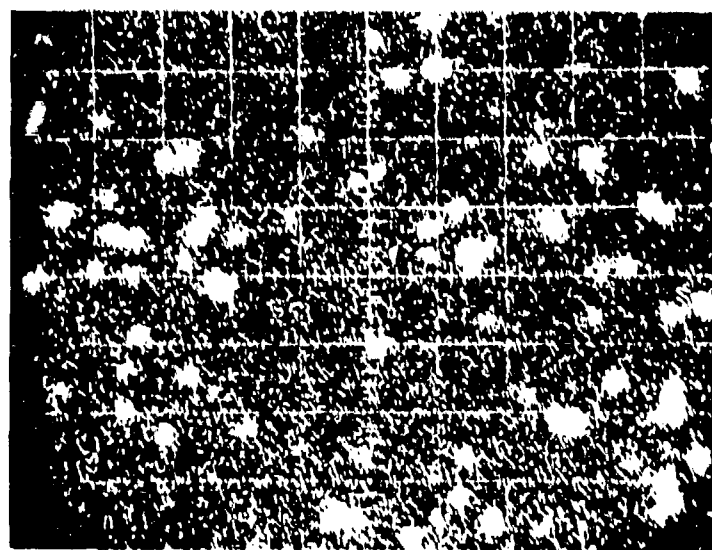
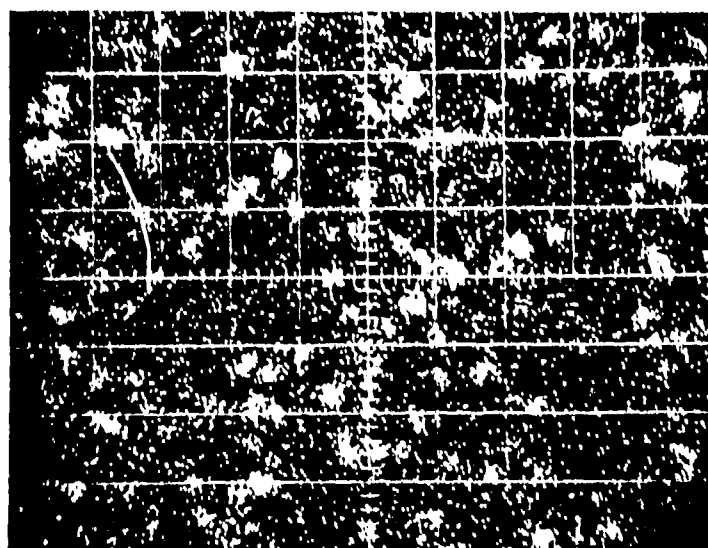
The first sample examined was the flat surface of the bulkhead from a failed fin (sample FA #1). The sample showed a linear defect extending almost entirely across the bulkhead surface. Figures 9A-F show electron probe scanning images for sample current, Al, Si, Mg, Mn, and Fe, respectively, at a magnification of 500x taken from a region of the bulkhead sample some distance from the crack. The scans are typical of normal 6070-T6 alloy. Note that although Al is rather homogeneously distributed across the alloy, the other elements are located at specific points on the alloy surface. These localized points represent second phase precipitates in the alloy. There is almost a direct one-to-one correspondence in distribution of Mg and Si; these points correspond to the second phase Mg_2Si . In addition, there is a similarity in distribution of Fe and Mn; these locations probably correspond to the second phase (Fe, Mn) Al_6 .

Figure 9A. Electron probe sample current scan showing a normal surface at 500x.

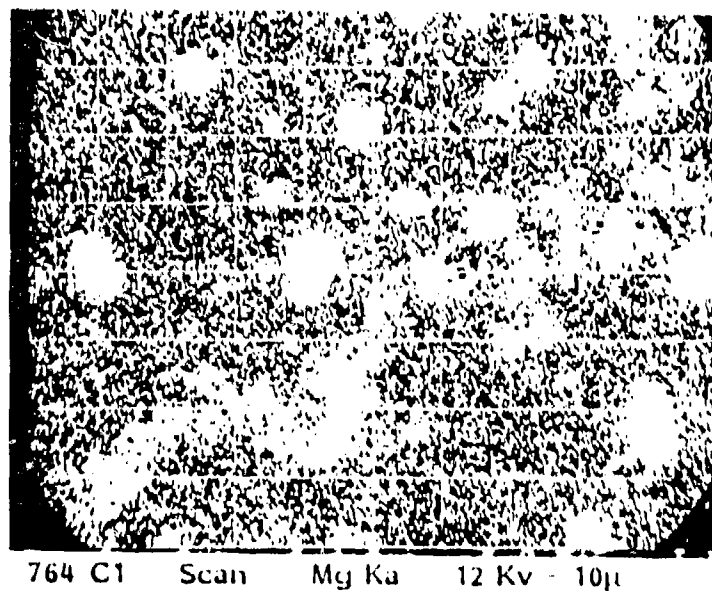
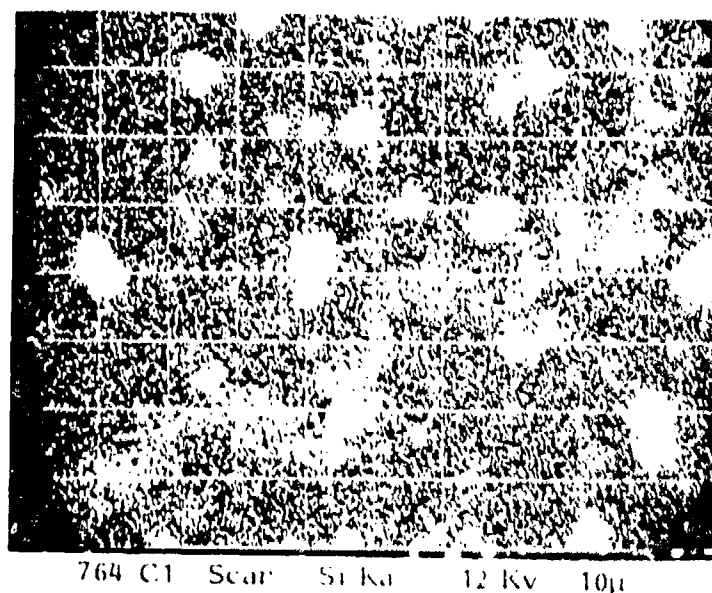
Figures 10A-E (1000x) show the same bulkhead samples as figures 9A-F, but in the region of the linear defect observed on the surface. This linear feature shows clearly on the sample current image (fig. 10A). A homogeneous Al distribution is apparent again in the Al scan (fig. 10B) but note its apparent absence in the defect. The Mg (fig. 10C) and Si (fig. 10D) scans show a bimodal distribution of the two elements, one normal and similar to that observed in figure 9C (Si) and 9D (Mg). In addition, however, there is a strong local concentration of Mg and Si at the same location as the defect. Finally, the oxygen scan (fig. 10E) confirms that the Mg and Si are present as oxides in the defect zone.

Figure 10A. Electron probe sample current scan showing a linear defect on the surface at 100x.
